RE: Taos Regional Landfill; Minor; Industrial Permit; SIC 4953; NPDES Compliance Evaluation Inspection; NPDES NMU001893; March 19, 2015

Compliance Evaluation Inspection Taos Regional Landfill March 19, 2015 NMU001893

Further Explanations

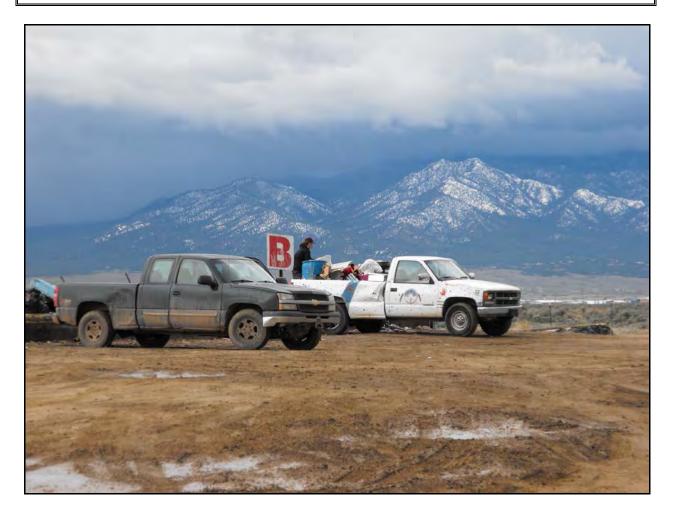
Photographer: Daniel Valenta	Date: 3/19/15	Time: 1532 hours		
City/County: Northwest of Taos, NM Taos County				
Location: Taos Regional Landfill, about 4.4miles northwest of Taos, N.M., sections 34 and 35 projected, range 12 east, township 26 north, NMPM, facing east.				
Subject: Unloading area at the TRLF.

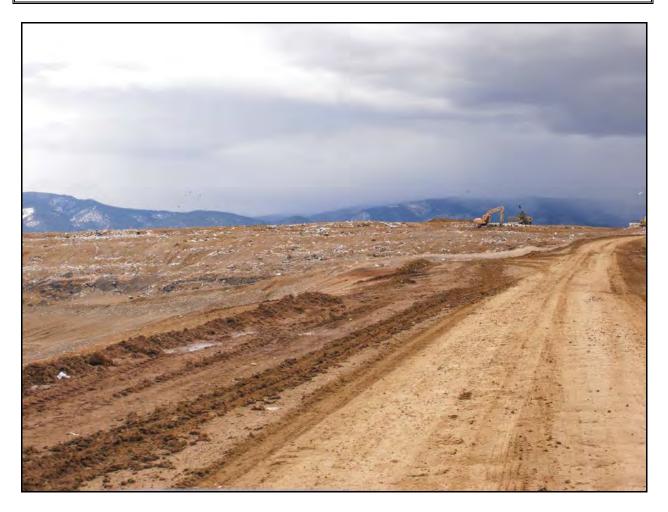
Photographer: Daniel Valenta	Date: 3/19/15	Time: 1537 hours		
City/County: Northwest of Taos, NM Taos County				
Location: TRLF, about 4.4miles northwest of Taos, N.M., sections 34 and 35 projected, range 12 east, township 26 north, NMPM, facing east.				
Subject: Storage cell at the TRLF. Rainstorm approaching facility.

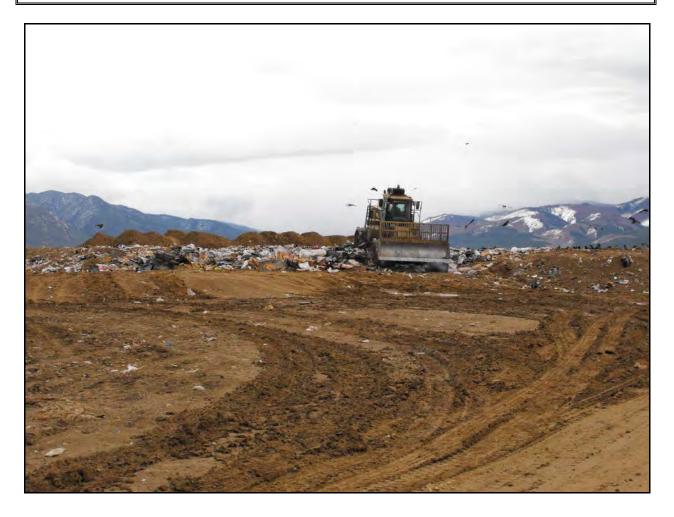
Photographer: Daniel Valenta	Date: 3/19/15	Time: 1539 hours		
City/County: Northwest of Taos, NM Taos County				
Location: TRLF, about 4.4miles northwest of Taos, N.M., sections 34 and 35 projected, range 12 east, township 26 north, NMPM, facing northeast.				
Subject: Activity at the TRLF, covering dirt in background.

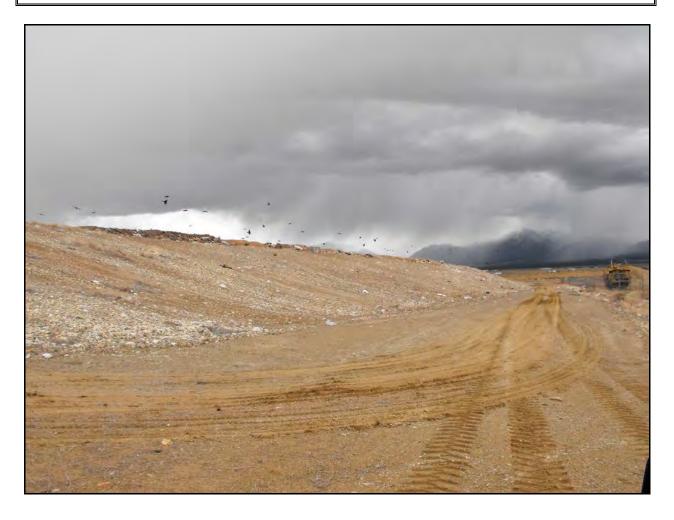
Photographer: Daniel Valenta	Date: 3/19/15	Time: 1539 hours		
City/County: Northwest of Taos, NM Taos County				
Location: TRLF, about 4.4miles northwest of Taos, N.M., sections 34 and 35 projected, range 12 east, township 26 north, NMPM, facing northeast.				
Subject: Storage cell at the TRLF. Rainstorm approaches facility.
